# Manhole Inspection Summary

Manhole # S01YY1011MH

**Location** Address: **3315 PINKNEY RD**

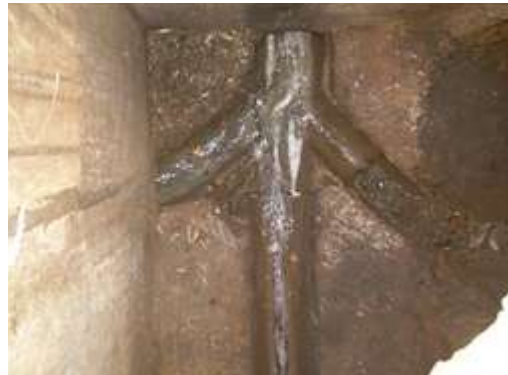
Top View

Corbel and Barrel infiltration. Channel debris.

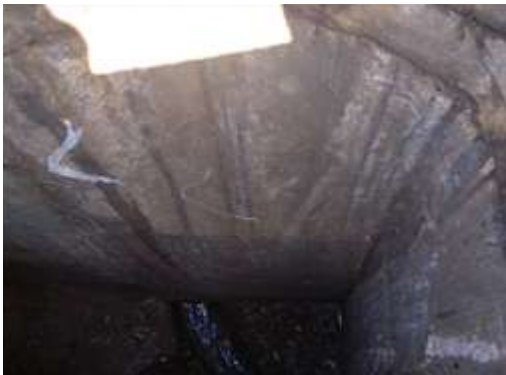
Defect

EVIDENCE OF INFILTRATION

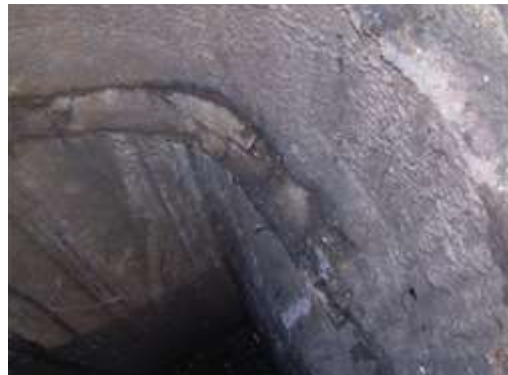
Defect

FRAME LEAKS

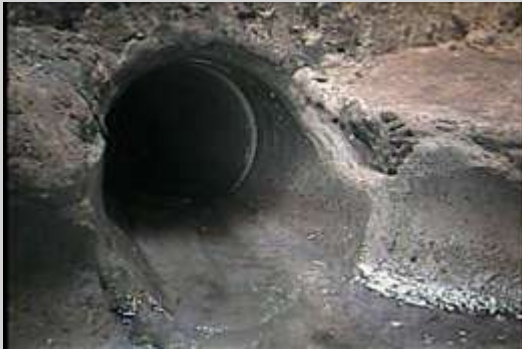
### 8 in. Circular Gravity Sewer Pipe Out @ 12 O'Clock

Infiltration: **None** Pipe Seal Cond: **Cracked**

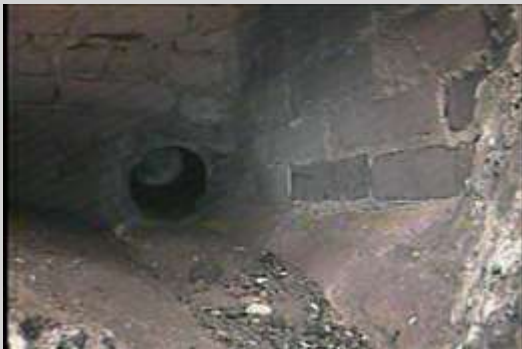
### 6 in. Circular Gravity Sewer Pipe In @ 3 O'Clock

Deposits: ☐ None ☐ Mud ☐ Sludge ☒ **Debris** ☐ Grease

Silt Depth: **0** (in.) Deposits Extent: **Light**

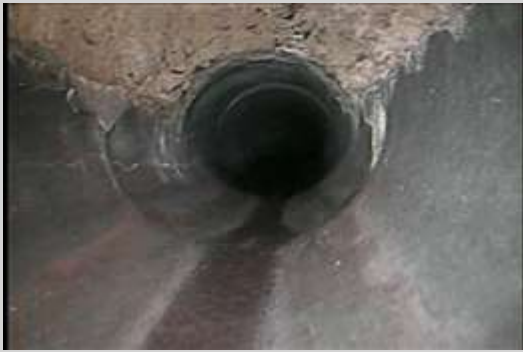
Pipe In @ 6 O'Clock

Channel cracks.

Infiltration: **Evidence** Pipe Seal Cond: **Unknown**
